Manhole Inspection Summary

Manhole # S35WW_032MH

Insp Date: **1/9/07 11:40 AM**

Location Address: **305 31ST ST**

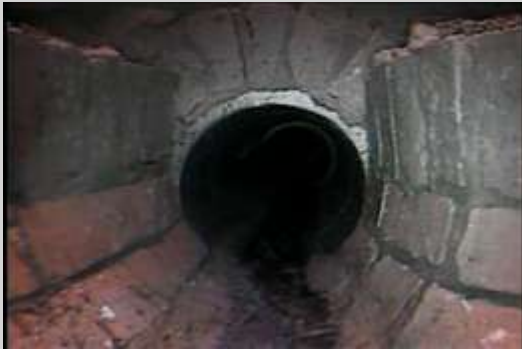
8 in. Circular Gravity Sewer Pipe Out @ 12 O'Clock

Pipe Material: **Clay** ☐ Pipe Lined

Invert Depth: **8.54** (ft.) Flow Characteristics: **Slow**

Deposits: ☒ None ☐ Mud ☐ Sludge ☐ Debris ☐ Grease

Infiltration: **None** Pipe Seal Cond: **Unknown**

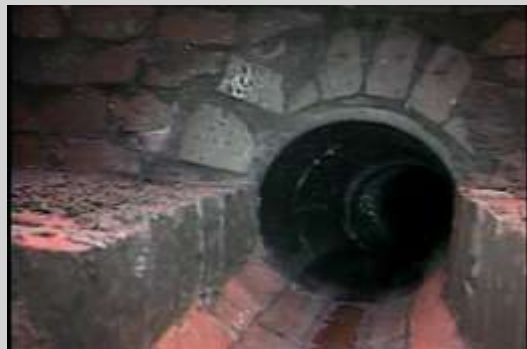
8 in. Circular Gravity Sewer

Pipe Material: **Clay**

Infiltration: **None**
